**FEDERAL AVIATION ADMINISTRATION
AIRWORTHINESS DIRECTIVES**

**SMALL AIRPLANES, ROTORCRAFT, GLIDERS,
BALLOONS, & AIRSHIPS**

BIWEEKLY 2012-25

2012-21-52 Agusta S.P.A. Helicopters (Type Certificate Currently Held By AgustaWestland S.P.A.) (Agusta): Amendment 39-17281; Docket No. FAA-2012-1135; Directorate Identifier 2012-SW-097-AD.

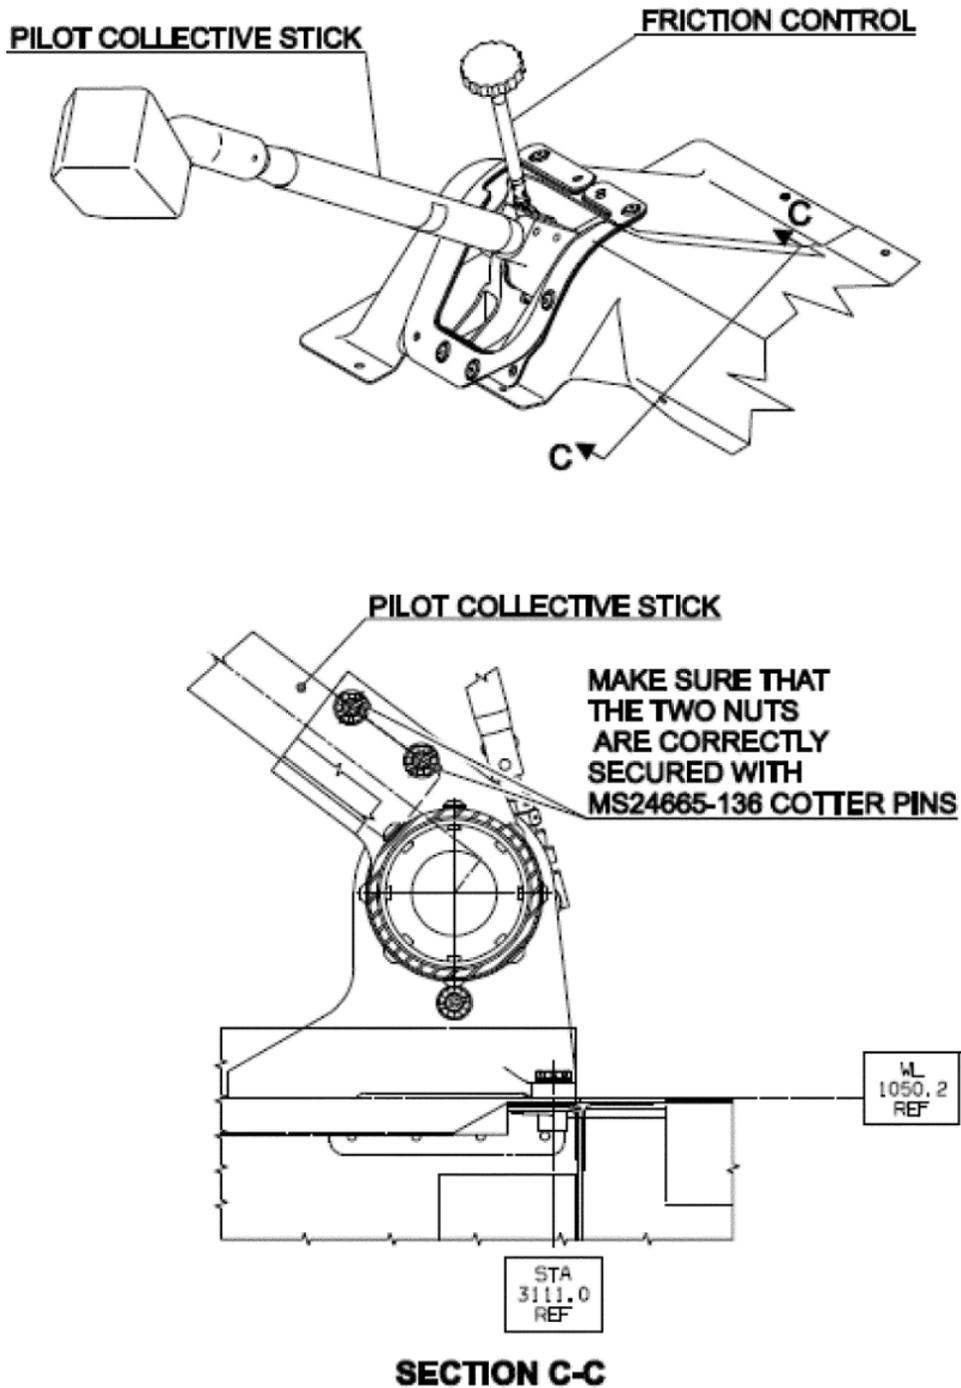
(1) Inspect the pilot collective stick installation to determine whether the self-locking nuts, part-number (P/N) MS17825-4, are secured with cotter pins, P/N MS24665-136, as depicted in Figure 1 to paragraph (e) of this AD. If the self-locking nuts are not secured with cotter pins, before further flight, reinstall the pilot collective stick.

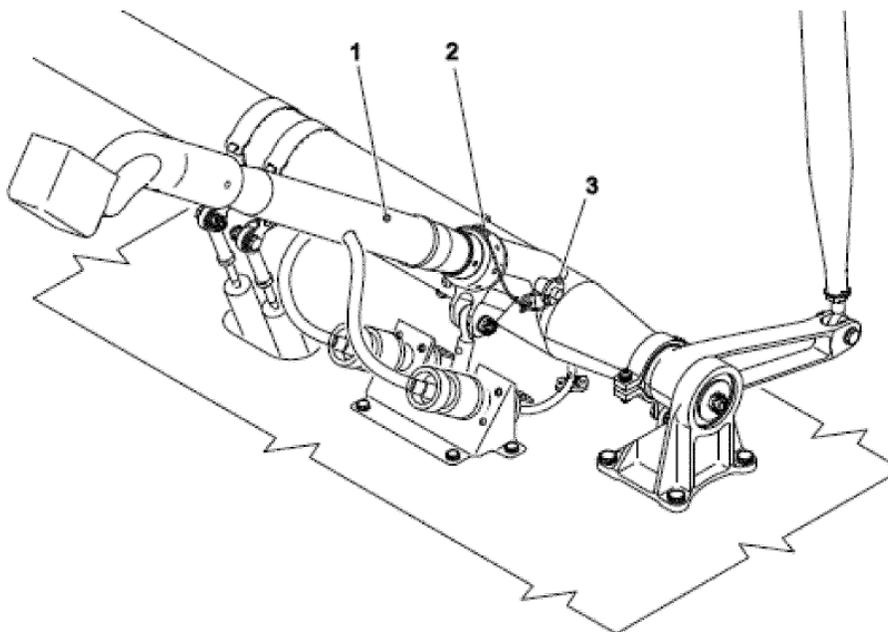
(2) Inspect the co-pilot collective stick installation to determine whether the ring nut (item 2) is loose and the quick-release pin (item 3) is installed as depicted in Figure 2 to paragraph (e) of this AD. If the ring nut is loose or the quick-release pin is not installed, before further flight, reinstall the co-pilot collective stick.

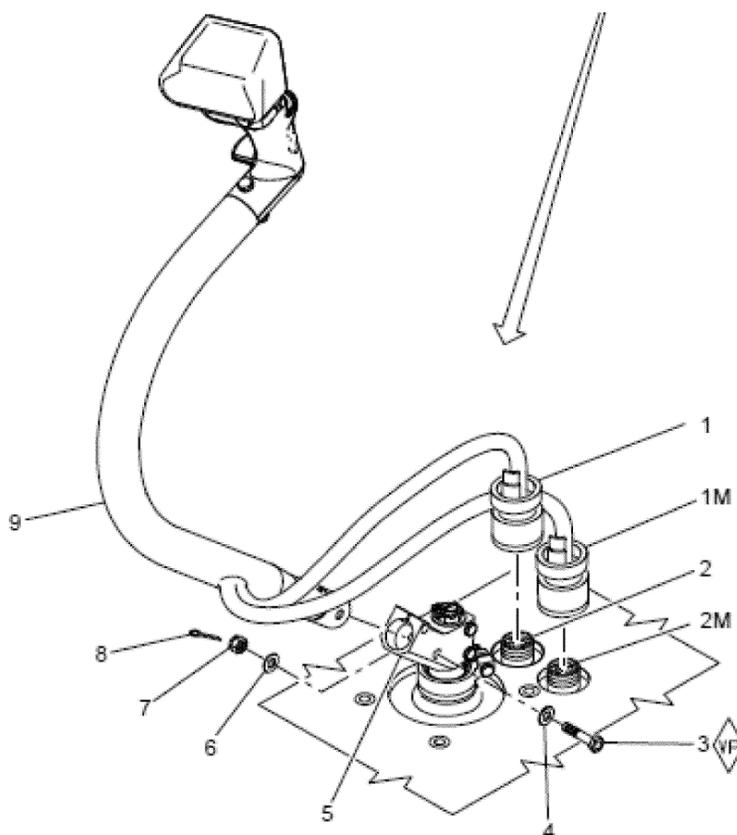
(3) Inspect the pilot cyclic stick installation for proper installation of the bolt (item 3), washer (item 4), self-locking nut (item 7), washer (item 6), and the cotter pin (item 8), as depicted in Figure 3 to paragraph (e) of this AD. If the pilot cyclic stick is not installed as depicted, before further flight, reinstall the pilot cyclic stick.

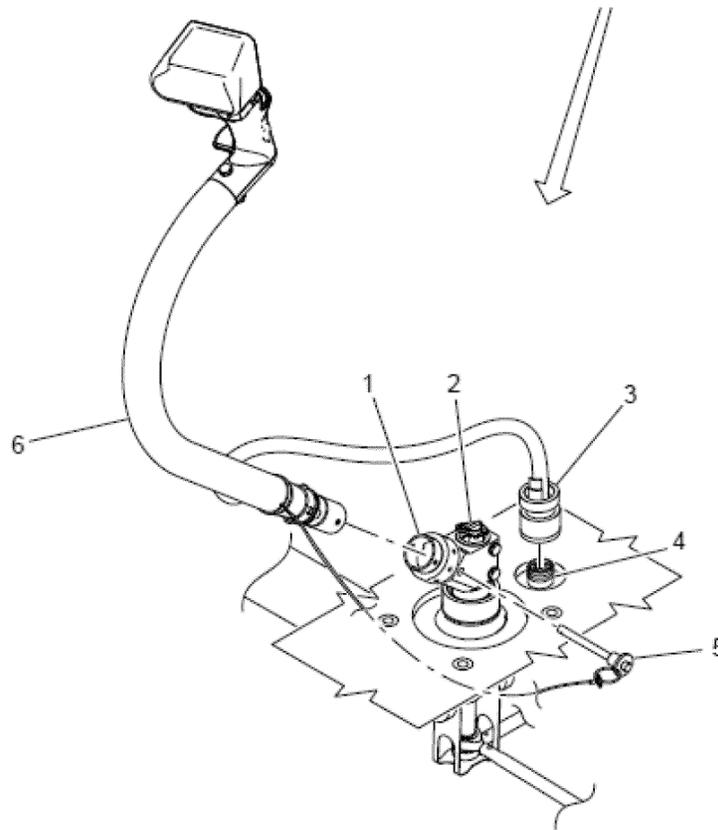
(4) Inspect the co-pilot cyclic stick installation to determine whether the ring nut (item 1) is loose and the quick-release pin (item 5) is installed as depicted in Figure 4 to paragraph (e) of this AD. If the ring nut is loose or the quick-release pin is not installed as depicted, before further flight, reinstall the co-pilot cyclic stick.
