[Docket No. FAA-2007-29089; Directorate Identifier 2007-NM-215-AD; Amendment 39-15197; AD 2007-18-52]

Airworthiness Directives; Boeing Model 737-600, -700, -700C, -800, -900, and -900ER Series Airplanes

2007-18-52 Boeing: Amendment 39-15197. Docket No. FAA-2007-29089; Directorate Identifier 2007-NM-215-AD.

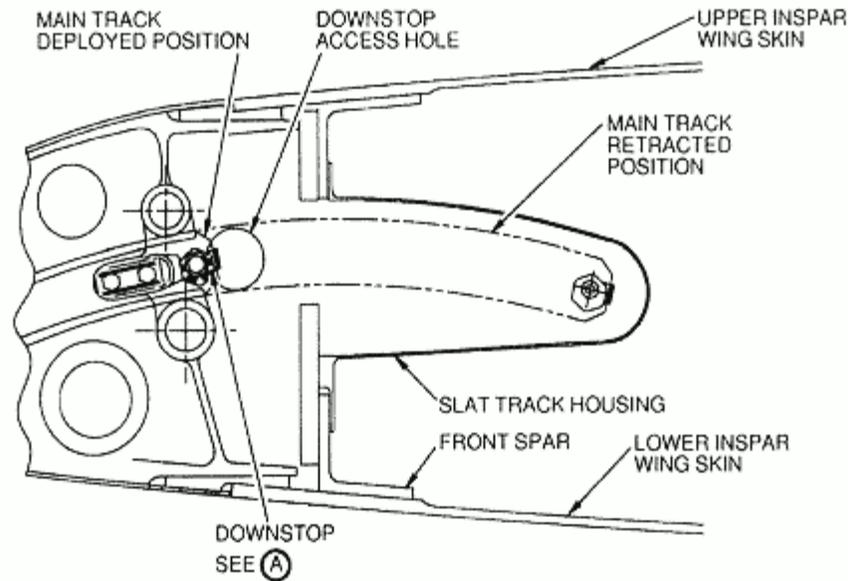
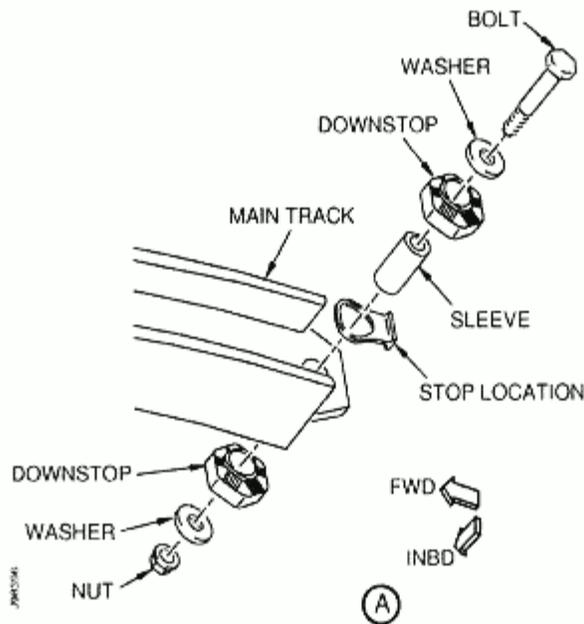
(d) This AD results from additional reports of parts coming off the main slat track downstop assemblies. We are issuing this AD to detect and correct loose or missing parts from the main slat track downstop assemblies, which could result in a fuel leak and consequent fire.

Slat Track Downstop Assembly

(f) Within 10 days after the effective date of this AD: Do a detailed inspection or a borescope inspection of each main slat track downstop assembly to verify proper installation of the slat track hardware (i.e., the bolt, washers, downstops, stop location, and nut shown in Figure 1 of Boeing Service Letter 737-SL-57-084-B, dated July 10, 2007, and in this AD). Proper installation of the sleeve need not be confirmed, and the stop location part may be installed on either the inboard or the outboard side of the slat track. If any part is missing or is installed improperly, before further flight, install a new or serviceable part using a method approved in accordance with the procedures specified in paragraph (h) of this AD; and do a detailed inspection of the inside of the slat can for foreign

object debris (FOD) and damage. Before further flight, remove any FOD found and repair any damage found using a method approved in accordance with the procedures specified in paragraph (h) of this AD. Using Boeing Multi Operator Message Number 1-523812011-1, issued August 25, 2007; or 1-527463441-1, issued August 28, 2007; is one approved method for verifying proper installation; installing a new or serviceable part; and inspecting for damage and FOD, and removing FOD and repairing damage. Repeat the actions required by paragraph (f) of this AD thereafter at intervals not to exceed 3,000 flight cycles.

(g) Within 24 days after receipt of AD 2007-18-51: Apply a torque between 50 to 80 inch-pounds to the nut. The bolt head must be held with the torque applied to the nut.
