[Docket No. FAA-2006-25773; Directorate Identifier 2006-SW-16-AD; Amendment 39-14758; AD 2006-19-01]

Airworthiness Directives; Eurocopter Model AS350B, B1, B2, B3, BA, D, and AS355E Helicopters

2006-19-01 Eurocopter: Amendment 39-14758. Docket No. FAA-2006-25773; Directorate Identifier 2006-SW-16-AD.

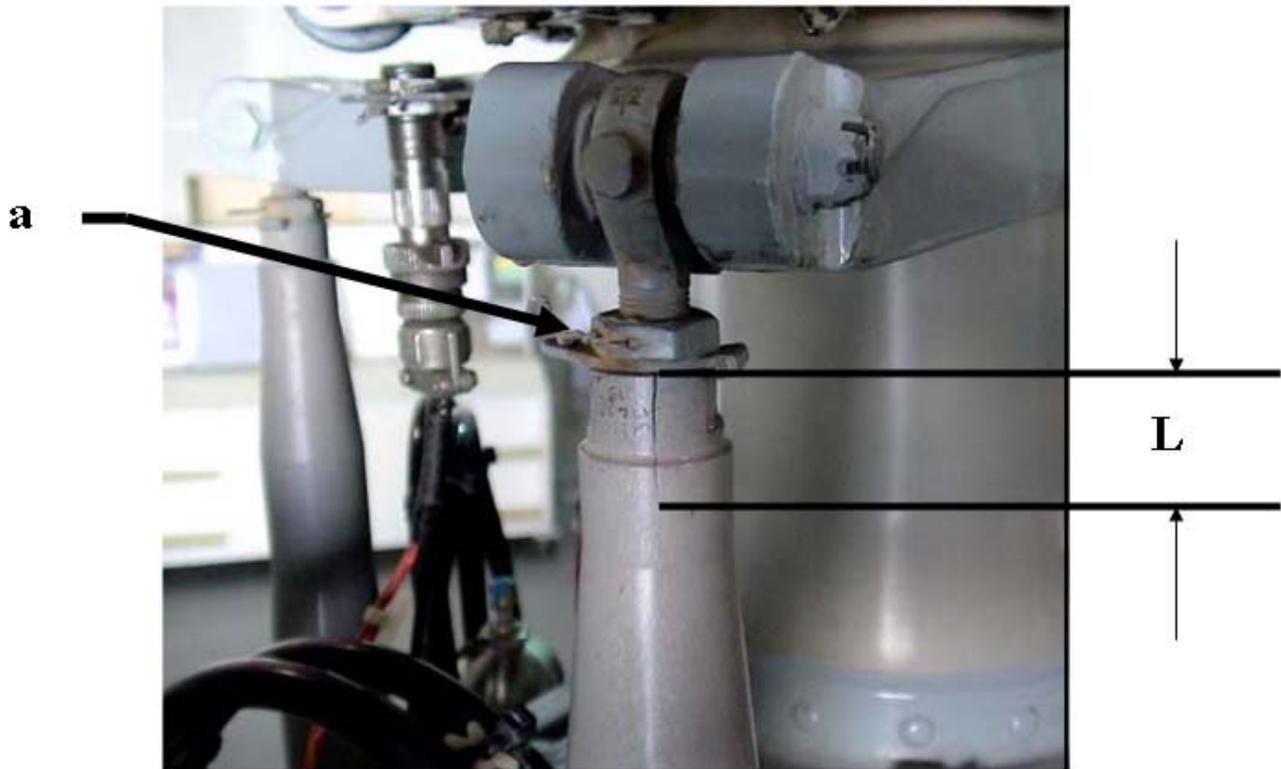
- (a) Within 10 hours time-in-service (TIS):
 - (1) Disconnect each MSC from the servo-control distributor and the upper attachment yoke.
 - (2) Cut the safety wire and remove it from the upper ball end of the attachment nut.
 - (3) Loosen attachment nut "a" shown in Figure 1 of this AD and lift the positioning lock washer under the attachment nut so the edge below the lock washer at the top of the tapered housing is visible around the entire periphery.
 - (4) Visually inspect each MSC tapered housing for a crack using a 10-power or higher magnifying glass paying particular attention to area "L" and to the edge of the tapered housing located under the lock washer under attachment nut "a" as depicted in Figure 1 of this AD.

(1) Adjust the tightening torque on the attachment nut that secures the upper ball end of the MSC to between 177-199 in-lbs (2-2.25 decanewton meters (daN·m)).

(c) If you find any crack (oblique, horizontal, or vertical), before further flight, replace the MSC with an airworthy MSC and adjust the tightening torque of the attachment nut to between 177-199 in-lb (2-2.25 daN·m)).
