[Docket No. 2002-NM-130-AD; Amendment 39-12840; AD 2002-16-01]

Airworthiness Directives; McDonnell Douglas Model DC-8-21, -31, -32, -33, -41, -42, and -43 Airplanes; and Model DC-8-50, -60, and -70 Series Airplanes; Modified per Supplemental Type Certificates SA1063SO, SA1862SO, or SA1832SO

2002-16-01 McDonnell Douglas: Amendment 39-12840. Docket 2002-NM-130-AD.

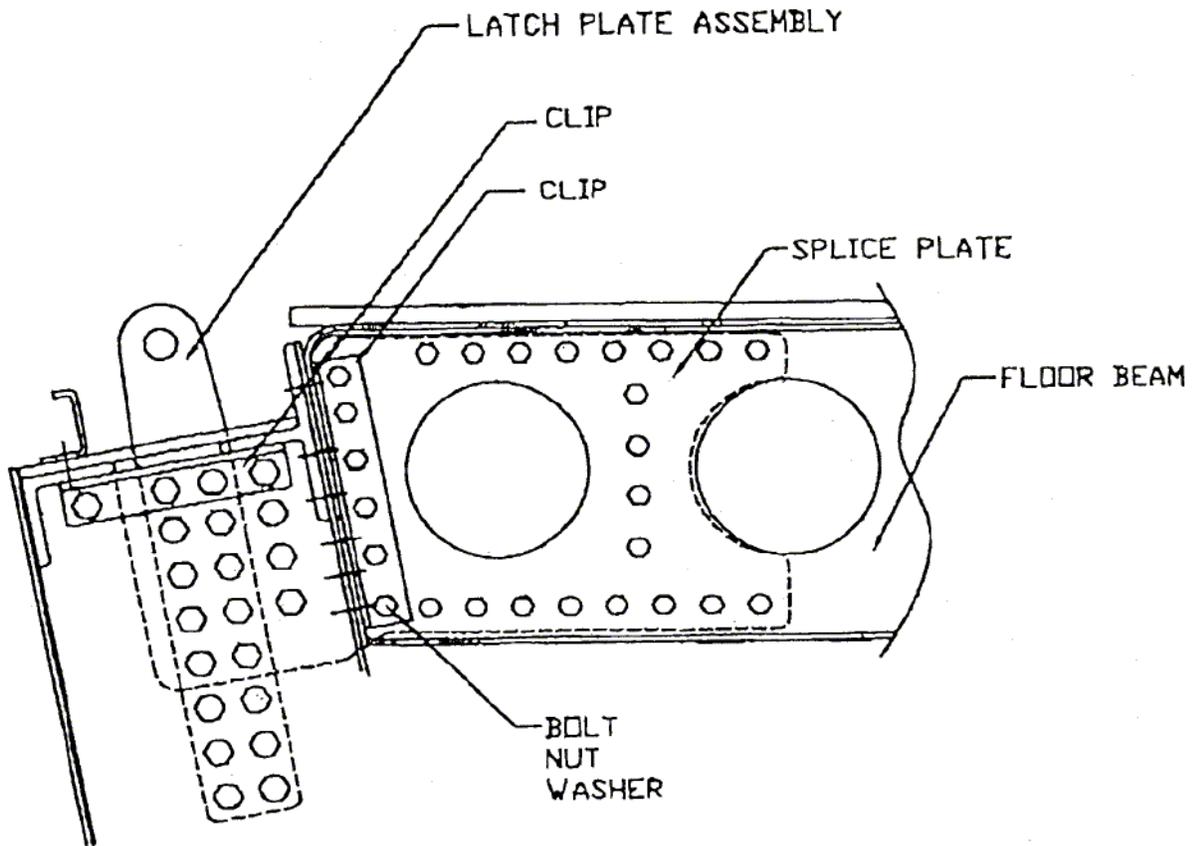
Figure 1.

SUPPLEMENTARY INFORMATION: The FAA has received several reports of findings of cracked or broken angles and splice plates on floor beam attachments to the lower door jamb of the main cargo door area on certain McDonnell Douglas Model DC-8-21, -31, -32, -33, -41, -42, and -43 airplanes; and Model DC-8-50, -60, and -70 series airplanes. One report revealed that, during a routine C-check on a Model DC-8-62 airplane, fractures were found in 9 of 11 of the floor beam attachments to the lower door jamb. Findings indicate that such fractures could be due to factors associated with flight operations and/or loading operations on the ground. Such conditions, if not corrected, could cause failure of such floor beam attachments during ground or flight operations. This could cause damage to the floor structure and consequent jamming of the control cables, and result in loss of controllability of the airplane in flight.

Since an unsafe condition has been identified that is likely to exist or develop on other airplanes of the same type design, this AD is being issued to prevent failure of the floor beam attachments to the lower door jamb. Such failure could cause damage to the floor structure and consequent jamming of the flight control cables, and result in loss of controllability of the airplane in flight. This AD requires gaining access to the floor beam attachments to the lower door jamb within the main cargo door area; and performing repetitive inspections to detect cracking or damage of such attachments, including splice plates, angles, and clips. If any cracking or damage is found, this AD also requires extending the area of inspection 60 inches forward and aft of the main cargo door area, and replacing any cracked or damaged part with a new part. Figure 1 of Appendix 1 of this AD identifies the inspection area and parts to be inspected.

(2) Perform a detailed inspection of the main cargo door area to detect any cracking or damage of the floor beam attachments to the lower door jamb, including the splice plates, angles, and clips identified in Figure 1 of Appendix 1 of this AD. Thereafter, repeat the inspection at intervals not to exceed 2,500 flight cycles or 18 months, whichever occurs earlier.

(b) If any cracking or damage is found during any inspection required by paragraph (a)(2) of this AD, before further flight, extend the area of inspection 60 inches forward and aft of the main cargo door area, and replace any cracked or damaged part with a new part identified in Figure 1 of Appendix 1 of this AD.
