**[Docket No. FAA-2014-0337; Directorate Identifier 2013-SW-029-AD; Amendment 39-18008; AD 2014-22-03]**

#### **Airworthiness Directives; Various Restricted Category Helicopters**

**2014-22-03 Various Restricted Category Helicopters:** Amendment 39-18008; Docket No. FAA-2014-0337; Directorate Identifier 2014-SW-029-AD.

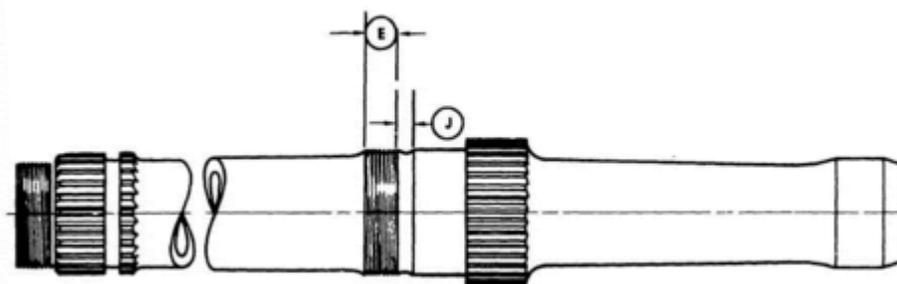
This AD defines the unsafe condition as a crack in the main rotor mast, which could result in failure of the mast and subsequent loss of control of the helicopter.

(i) Remove any surface rust with a wire brush or steel wool and, using a 10X or higher power magnifying glass, inspect the areas of the mast as shown in area E and area J of Figure 1 to Paragraph (f) of this AD for pitting, corrosion, or a crack.

(2) If there is a crack, pitting, or corrosion, before further flight, replace the mast with an airworthy mast.
