[Docket No. 2003-SW-38-AD; Amendment 39-13686; AD 2004-13-05]

Airworthiness Directives; Eurocopter Deutschland Model MBB-BK 117 A-1, A-3, A-4, B-1, B-2, and C-1 Helicopters

2004-13-05 Eurocopter Deutschland: Amendment 39-13686. Docket No. 2003-SW-38-AD.

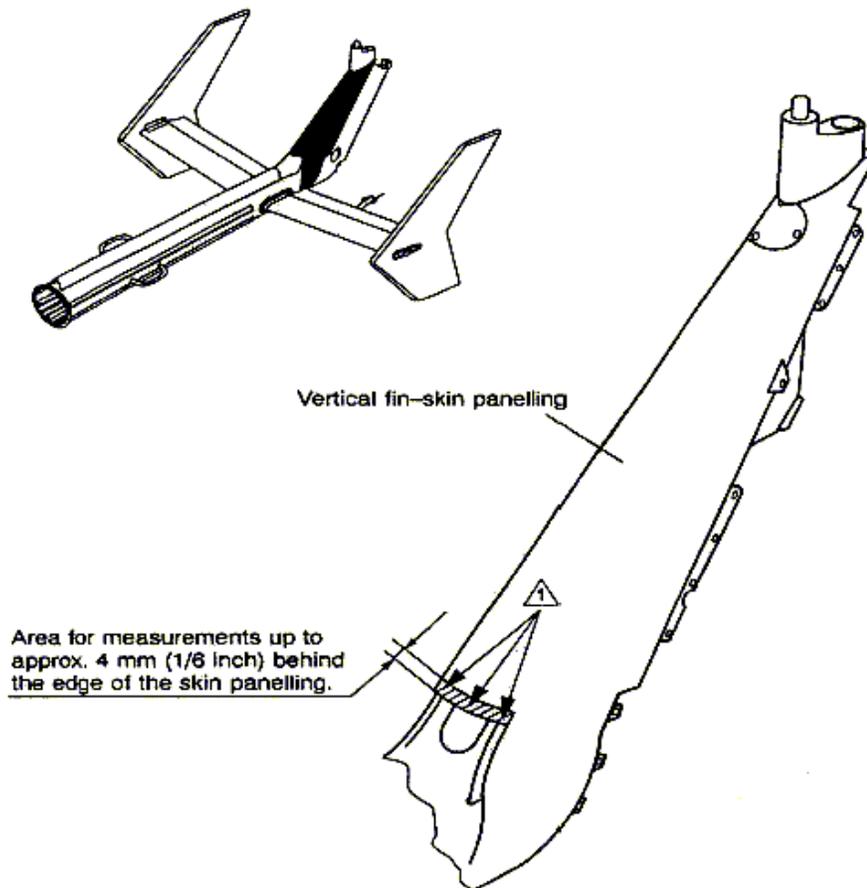
Vertical Fin-Skin Panelling
Figure 1

The Luftfahrt-Bundesamt (LBA), the airworthiness authority for the Federal Republic of Germany, notified the FAA that an unsafe condition may exist on ECD Model MBB-BK117 helicopters, Model A-1 up to B-2, serial number (S/N) all, and Model C-1, S/N 7500 up to 7545. The LBA advises that during tail boom production, metal sheeting of 0.6-millimeter (mm) thickness was found instead of the specified 0.8-mm thickness for the skin paneling of several tail booms.

(a) Using external calipers, measure the wall thickness, including primer coating, of the skin paneling of the vertical fin at the locations shown in Figure 1 of this AD.

△ Measurements are to be taken at at least three locations on the skin panel of the vertical fin. Care has to be taken that the external calipers are held squarely to the skin panel wall while measurements are being taken, since tilting of the calipers can lead to false results. If the panel thickness, including the primer coating, is at least 0.778 mm (0.03063 inch) at every measured location, no further action is necessary.

(b) If the wall thickness, including the primer coating, of the panelling is less than 0.778 millimeter (0.03063 inch) at any of the measured locations, replace the vertical fin with an airworthy part before further flight.
