**FEDERAL AVIATION ADMINISTRATION
AIRWORTHINESS DIRECTIVES
LARGE AIRCRAFT**

BIWEEKLY 2009-09

2009-08-07 Honeywell International Inc. (Formerly AlliedSignal and Lycoming): Amendment 39-15880. Docket No. FAA-2008-1207; Directorate Identifier 2007-NE-47-AD.

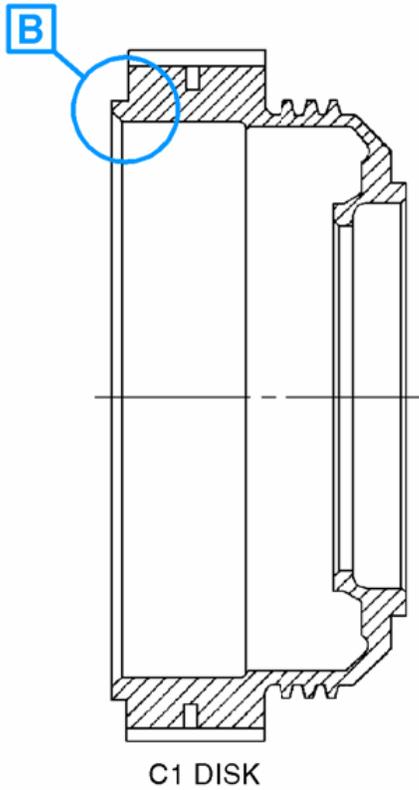
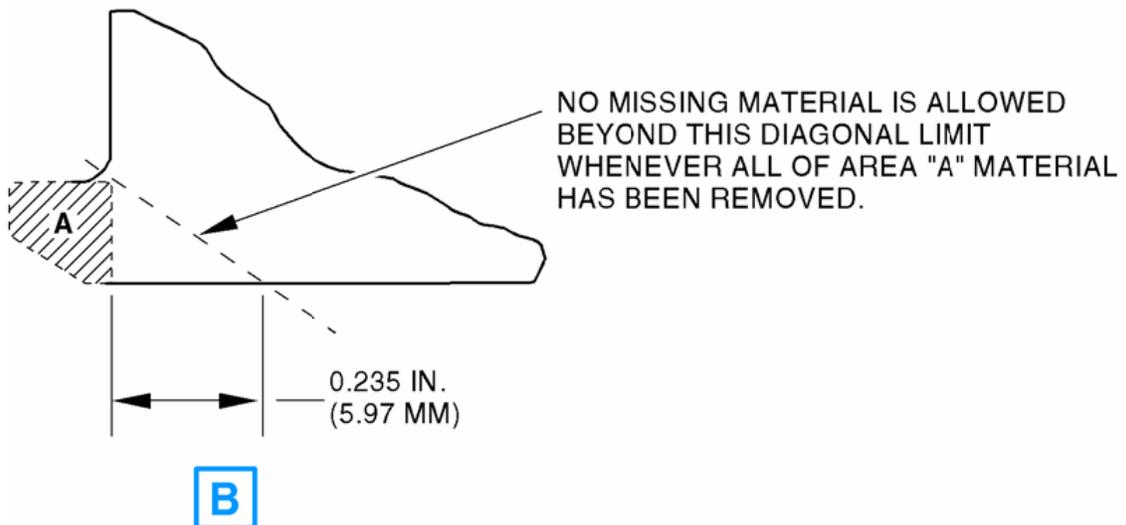
Limits for Removed Balance Material, Disc Forward Flange
Figure 1 (Sheet 1 of 2)

(f) For discs with 5,000 or more cycles-since-new on the effective date of this AD, perform a dimensional inspection of the HPC first stage disc to determine if excessive disc balance material was removed. See the following Figure 1 for limits.

(g) Replace the disc if excessive disc balance material was removed. See limits in Figure 1 of this AD.

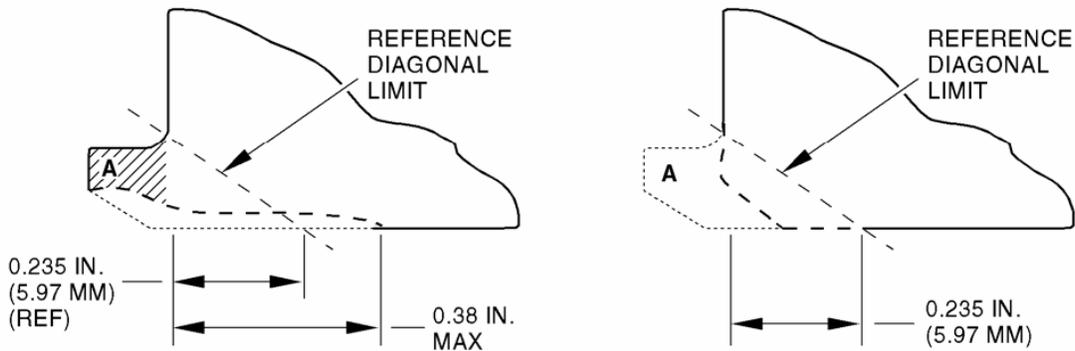
EXAMPLES OF ACCEPTABLE REMOVED MATERIAL CONDITION

Any remaining Area 'A' lip material is sufficient to permit axial material removal up to 0.38 inch (0.97 mm) limit. Surface shall have a smooth contour and 0.020 inch (0.51 mm) minimum blend radius.

Removal of all Area 'A' material is permitted when axial material removal is less than 0.235 inch (5.97 mm) diagonal limit. Surface shall have a smooth contour and 0.020 inch (0.51 mm) minimum blend radius.
