[Docket No. FAA-2013-0486; Directorate Identifier 2010-SW-031-AD; Amendment 39-17622; AD 2013-20-16]

Airworthiness Directives; MD Helicopters, Inc. (MDHI) Helicopters

ACTION: Final rule.

2013-20-16 MD Helicopters, Inc. (MDHI): Amendment 39-17622; Docket No. FAA-2013-0486; Directorate Identifier 2010-SW-031-AD.

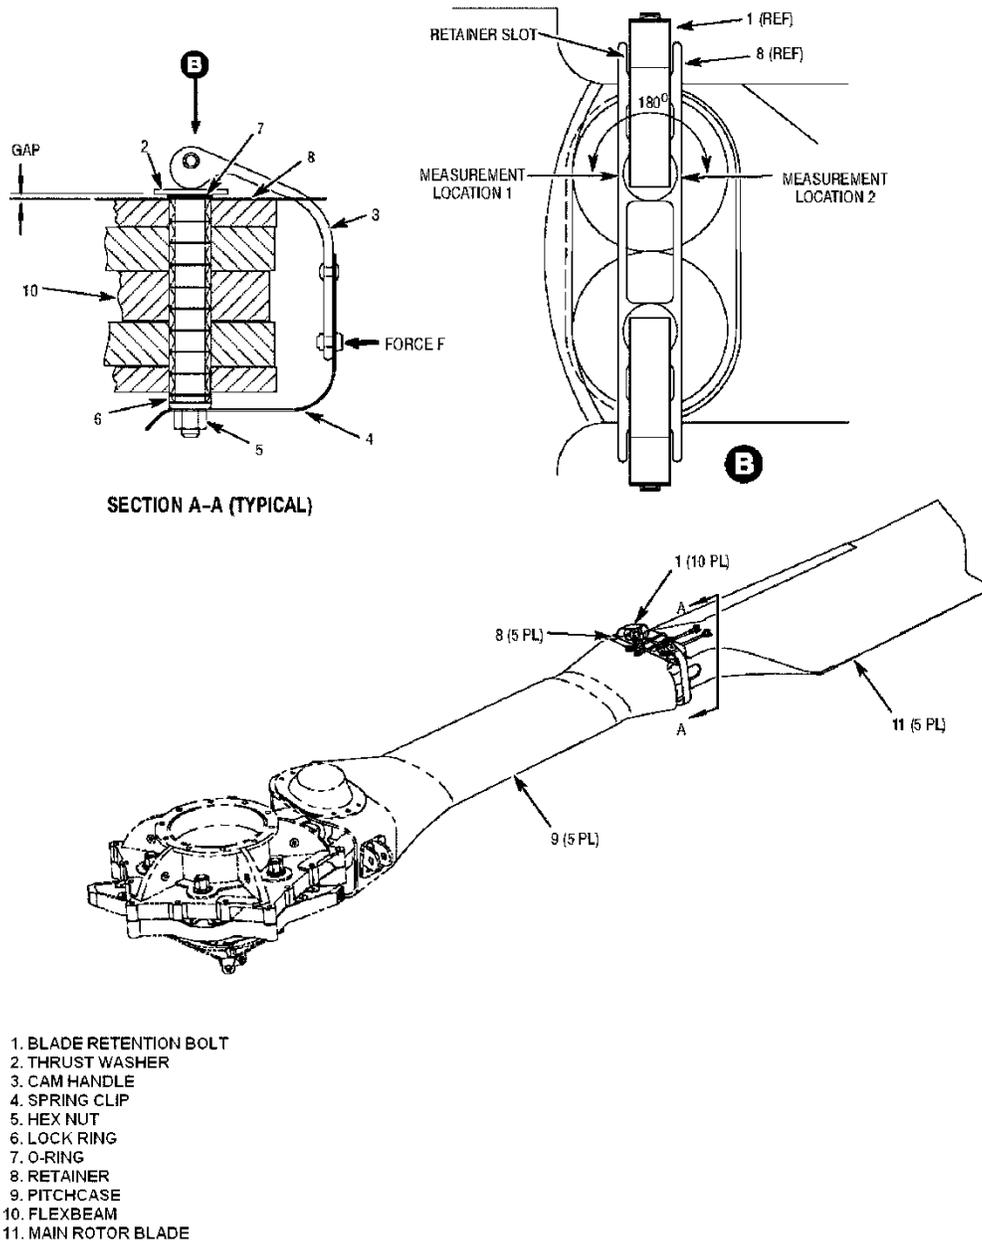
Figure 1 to Paragraph (e)
Gap and Force Check of the Blade Retention Bolts

This AD defines the unsafe condition as bolt failure. This condition could result in loss of main rotor blade structural integrity and subsequent loss of control of the helicopter.

(ii) Visually check for a gap between the thrust washer and the retainer, P/N 900R2100009-101 or -103. The thrust washer is depicted as item 2 and the retainer is depicted as item 8 in Figure 1 to paragraph (e) of this AD.

(iv) If there is any indication of bolt failure or if there is no gap between the thrust washer and retainer, before further flight, remove and inspect the bolt for a crack. Replace any cracked bolt with an airworthy bolt.

(iii) If there is a gap between the thrust washer and retainer, measure the gap in two locations, 180 degrees apart, with a feeler gage. If the gap is more than 0.100 inch (2.54 mm) at either location, before further flight, remove and inspect the bolt for a crack. Replace any cracked bolt with an airworthy bolt.
