**[Docket No. FAA-2005-22712; Directorate Identifier 2005-NE-24-AD; Amendment 39-14367; AD 2005-23-09]**

#### **Airworthiness Directives; General Electric Company (GE) CF6-80E1A1, -80E1A2, -80E1A3, -80E1A4, and -80E1A4/B Turbofan Engines**

**2005-23-09 General Electric Company:** Amendment 39-14367. Docket No. FAA-2005-22712; Directorate Identifier 2005-NE-24-AD.

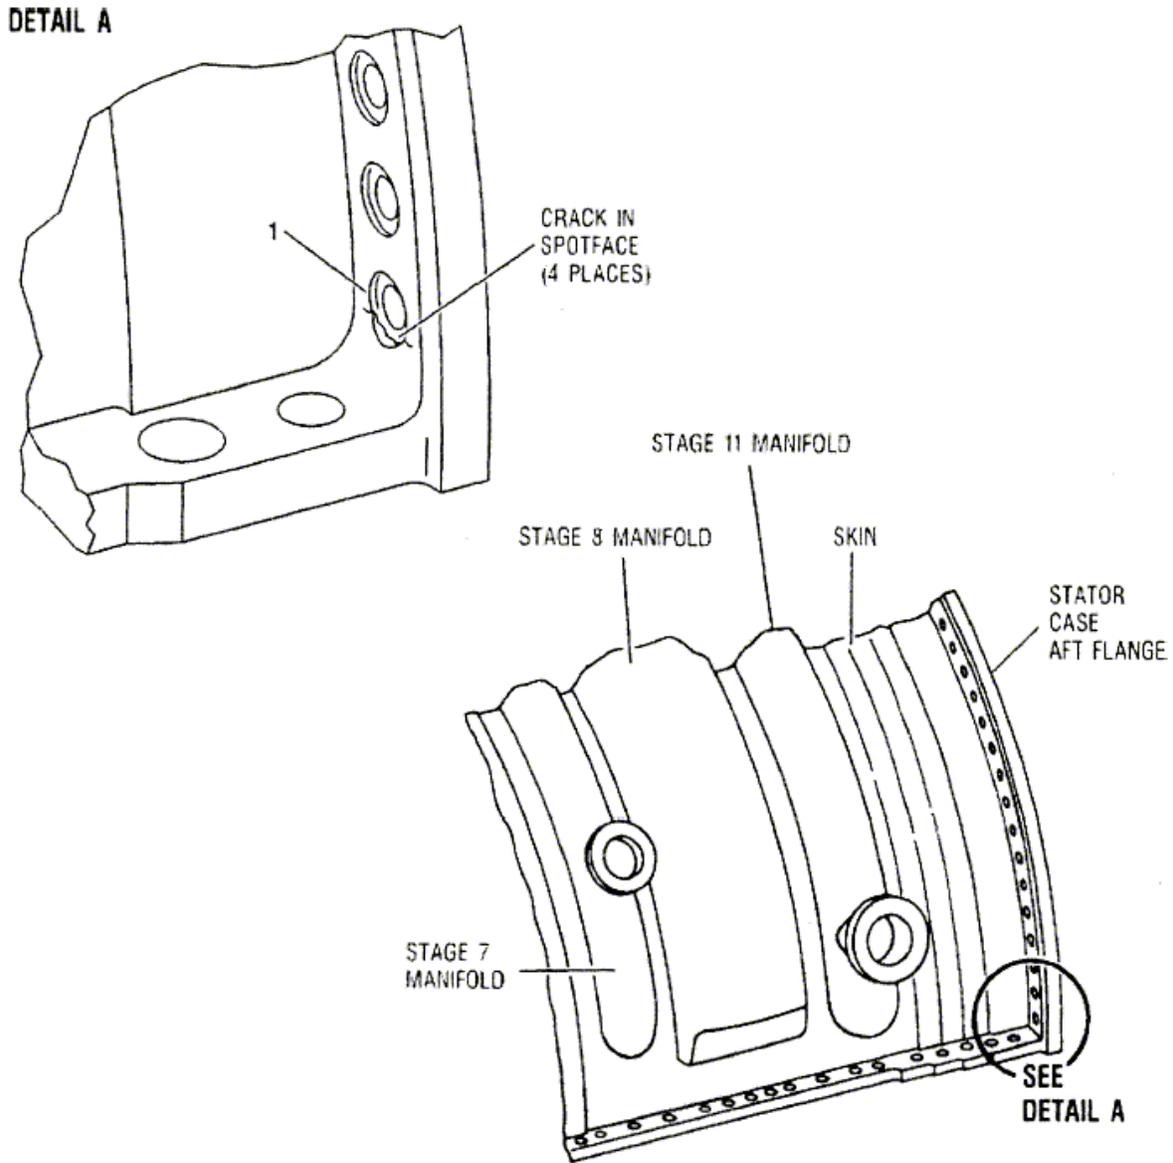
Figure 1.

(d) This AD results from the discovery that high pressure compressor (HPC) cases, part number (P/N) 1509M97G07 and P/N 2083M69G03, were inadvertently left out of the Airworthiness Limitations Section (ALS), Chapter 05-21-02, of GE Engine Manual GEK 99376, Revision 17. We are issuing this AD to prevent failure of the HPC case aft flange, due to cracking.

(f) For HPC cases, P/N 1509M97G07 and P/N 2083M69G03, perform an initial fluorescent-penetrant inspection (FPI) of circumferential flange spotfaces at the first hole in the aft flange above and below each horizontal split line flange, at or before reaching 7,300 cycles-since-new. See Figure 1 of this AD for reference. Information on inspecting these areas can be found in the ALS of GE Engine Manual GEK 99376, Revision 19, dated August 15, 2005.

(g) Perform repetitive FPI of circumferential flange spotfaces at the first hole in the aft flange above and below each horizontal split line flange, within 3,700 cycles-since-last-inspection. See Figure 1 of this AD for reference. Information on inspecting these areas can be found in the ALS of GE Engine Manual GEK 99376, Revision 19, dated August 15, 2005.
