[Docket No. FAA-2011-1231; Directorate Identifier 2011-NM-088-AD; Amendment 39-17418; AD 2013-08-01]

Airworthiness Directives; The Boeing Company Airplanes

SUMMARY: We are adopting a new airworthiness directive (AD) for certain The Boeing Company Model 737-600, -700, -700C, -800, -900, and -900ER series airplanes. This AD was prompted by reports of damaged fire seals on the forward edge of the thrust reverser. This AD requires inspecting to detect damage to the upper fire seals on the forward edge of the thrust reverser, where the fire seal contacts the 12-o'clock engine strut, and for correct stiffness and vent holes, and doing corrective actions if necessary; and installing a bracket for the fire seal. We are issuing this AD to detect and correct damage to the fire seals, which could allow airflow into the engine fire zone and could degrade the ability to extinguish an engine fire.

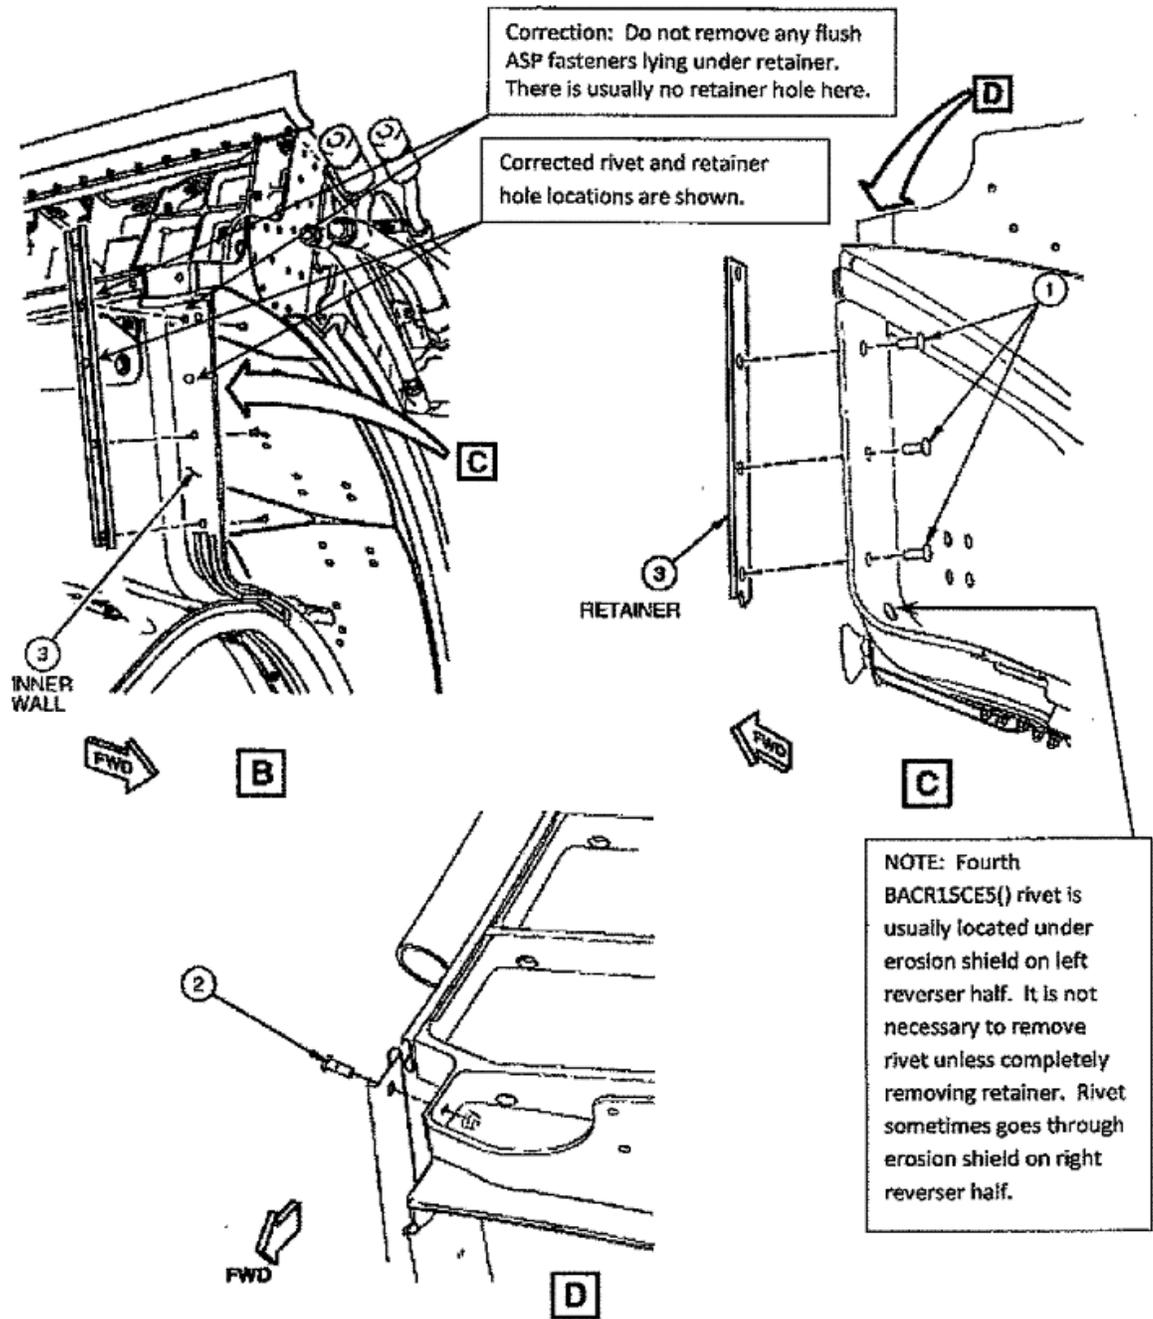
Figure 1, Fastener Removal of the Retainer Support on the Left Thrust Reverser Half

(2) Figures 1 and 3 of this AD, titled "Fastener Removal of the Retainer Support on the Left (Right) Thrust Reverser Half," have View B showing the top fastener in the center of three adjustable sustained preload (ASP) fasteners. That top fastener does not require removal in order to remove the retainer. The figures in this AD point to the correct information for those fasteners.

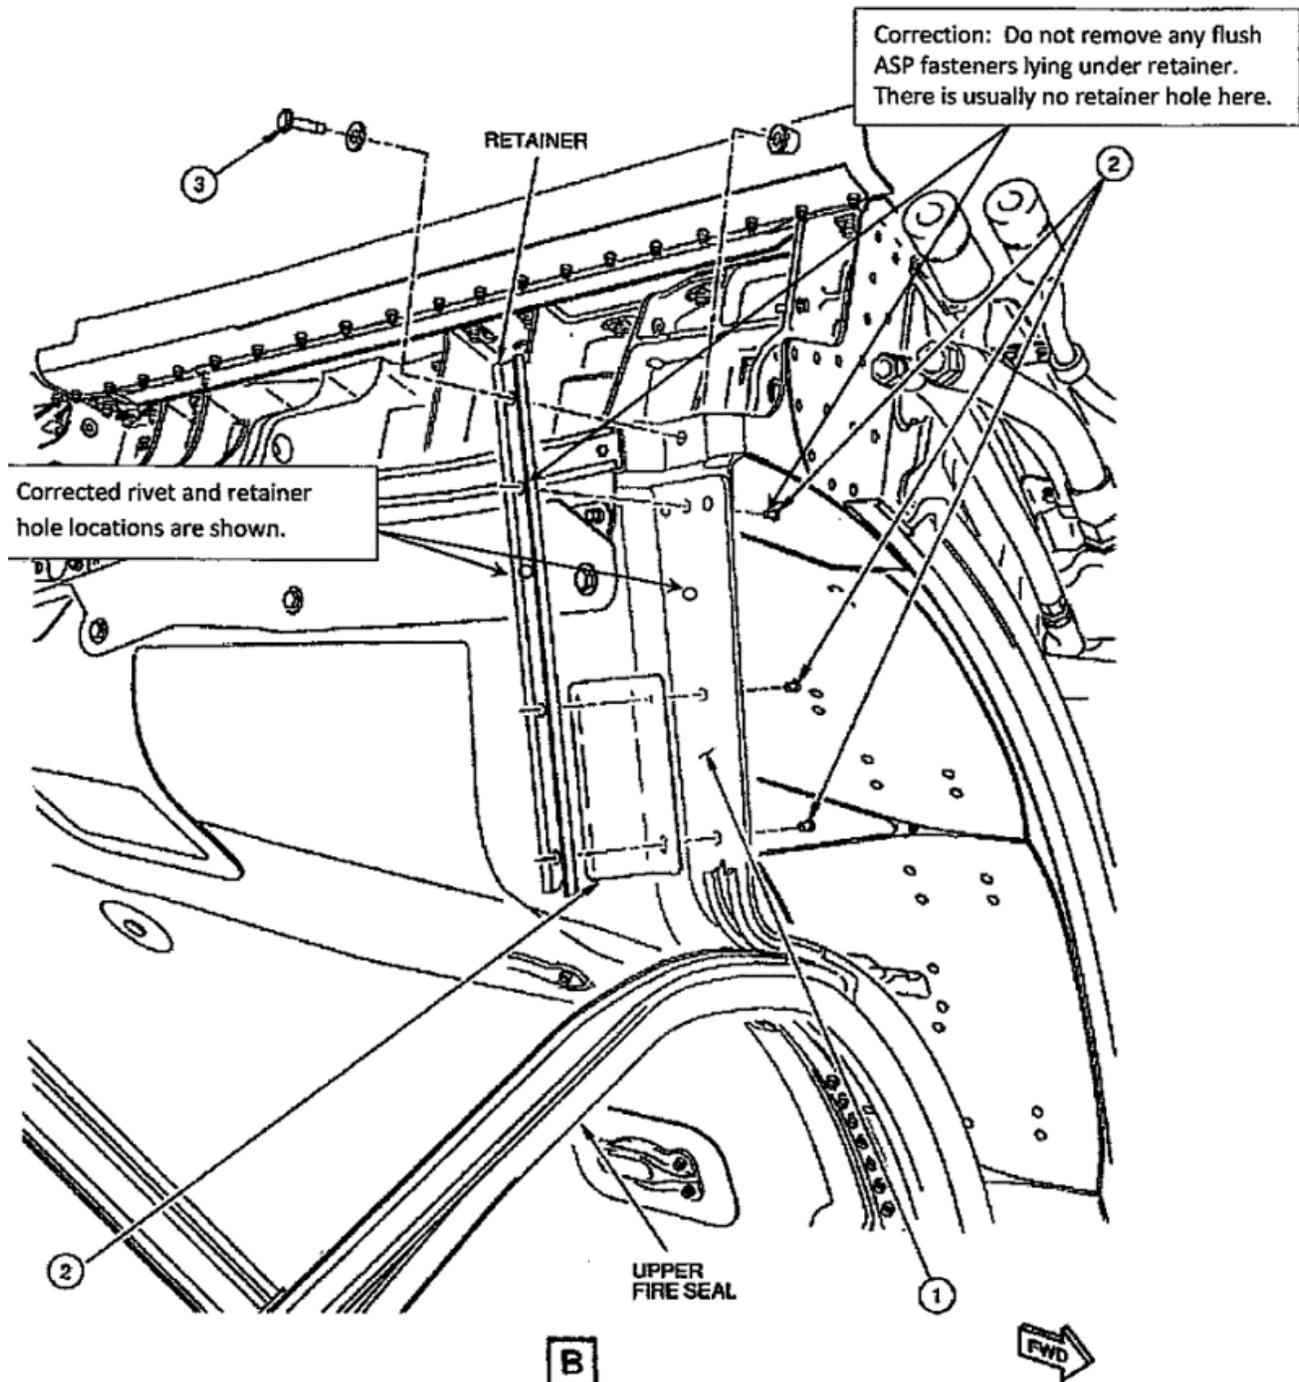
Figure 2, Installation of the New Bracket behind the Retainer Support on the Left Thrust Reverser Half

(3) Figures 2 and 4 of this AD, titled "Installation of the New Bracket behind the Retainer Support on the Left (Right) Thrust Reverser Half," have View B showing the top rivet hole. That rivet hole is actually below the row of three ASP fasteners. The figures in this AD point to the correct information for those rivet holes.
