[Docket No. FAA-2012-0807; Directorate Identifier 2011-NM-191-AD; Amendment 39-17888; AD 2014-13-12]

Airworthiness Directives; Airbus Airplanes

SUMMARY: We are adopting a new airworthiness directive (AD) for all Airbus Model A318, A319, A320, and A321 series airplanes. This AD was prompted by reports of silicon particles inside the oxygen generator manifolds, which had chafed from the mask hoses during installation onto the generator outlets. This AD requires identifying the part number and serial number of each passenger oxygen container, replacing the oxygen generator manifold of any affected oxygen container with a serviceable manifold, and performing an operational check of the manual mask release, and corrective actions if necessary. We are issuing this AD to detect and correct non-serviceable oxygen generator manifolds, which could reduce or block the oxygen supply and result in injury to passengers when oxygen supply is needed.

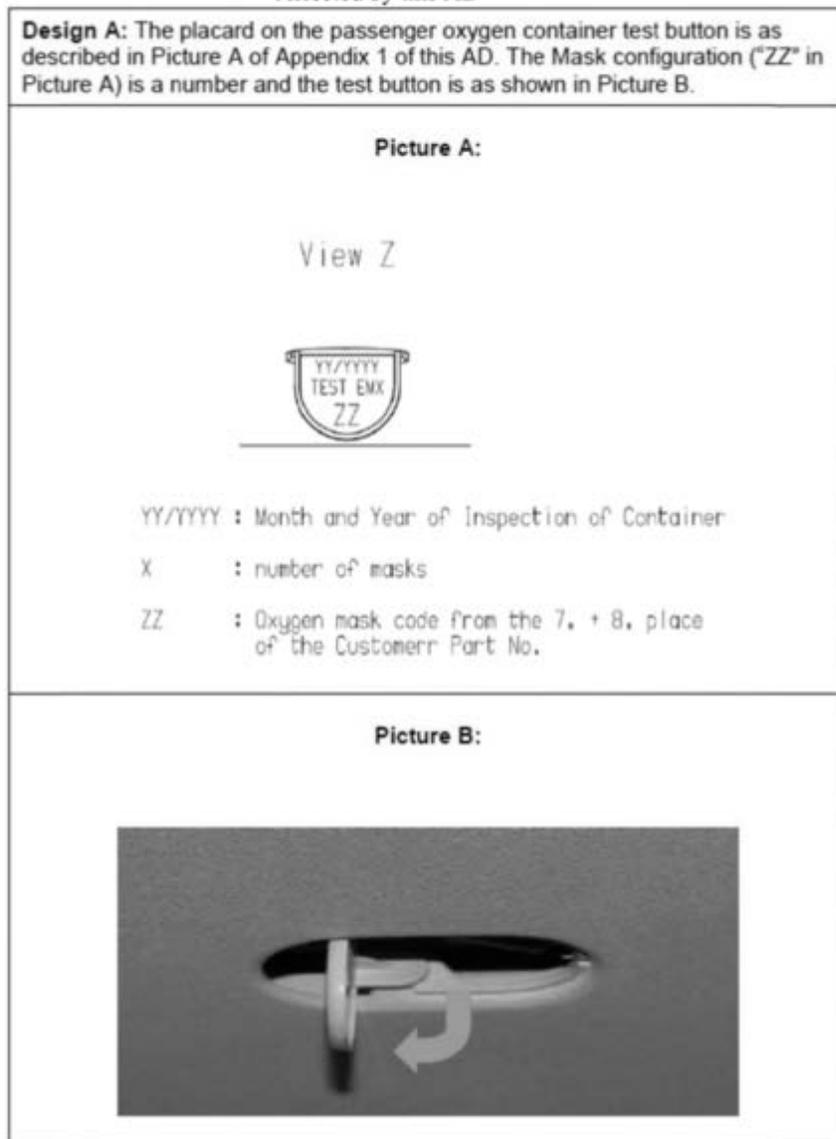
Figure 1 to paragraph (i)(7) of this AD – Design A of the Passenger Oxygen Containers Affected by this AD

(7) The requirements of paragraphs (g) and (h) of this AD apply only to passenger oxygen containers that are Design A, as defined in figure 1 to paragraph (i)(7) of this AD.
