[Docket No. FAA-2012-1128; Directorate Identifier 2012-SW-064-AD; Amendment 39-17225; AD 2012-21-09]

Airworthiness Directives; Eurocopter France Helicopters

2012-21-09 Eurocopter France: Amendment 39-17225; Docket No. FAA-2012-1128; Directorate Identifier 2012-SW-064-AD.

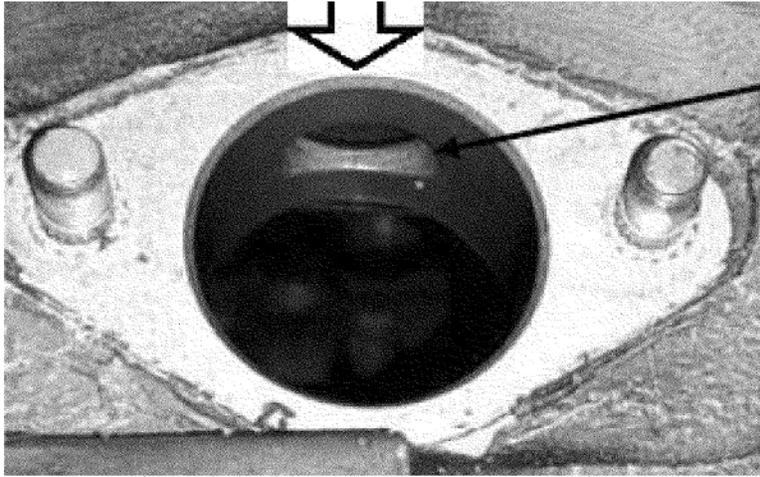
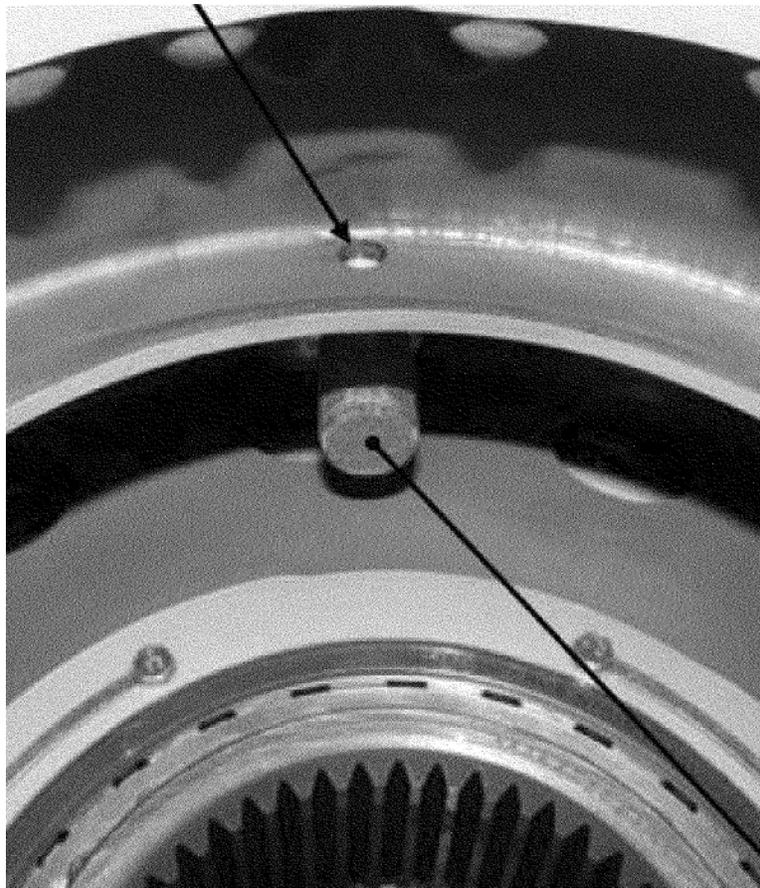
This AD defines the unsafe condition as a missing through-hole, joining the integrated collector to the magnetic plug. This condition could result in failure of the chip-detector system to detect deterioration of the main rotor mast lift bearing, failure of the lift bearing, and subsequent loss of control of the helicopter.

(ii) Determine if the hole above the magnetic plug is a through-hole as shown in figures 1 and 2 to paragraph (e)(1)(ii) of this AD.

(2) If the hole above the magnetic plug is not a through-hole, before further flight, replace the epicyclic module with an airworthy epicyclic module.
