AIRWORTHINESS DIRECTIVE

AD #: 2011-15-51

2011-15-51 BELL HELICOPTER TEXTRON CANADA: Directorate Identifier 2011-SW-038-AD.

Applicability: Model 407 helicopters with a hydraulic servo actuator assembly (servo), part number (P/N) 206-076-062-105, or -107 and Model 427 helicopters, with servo, P/N 206-076-062-109 or -111, installed, certificated in any category.

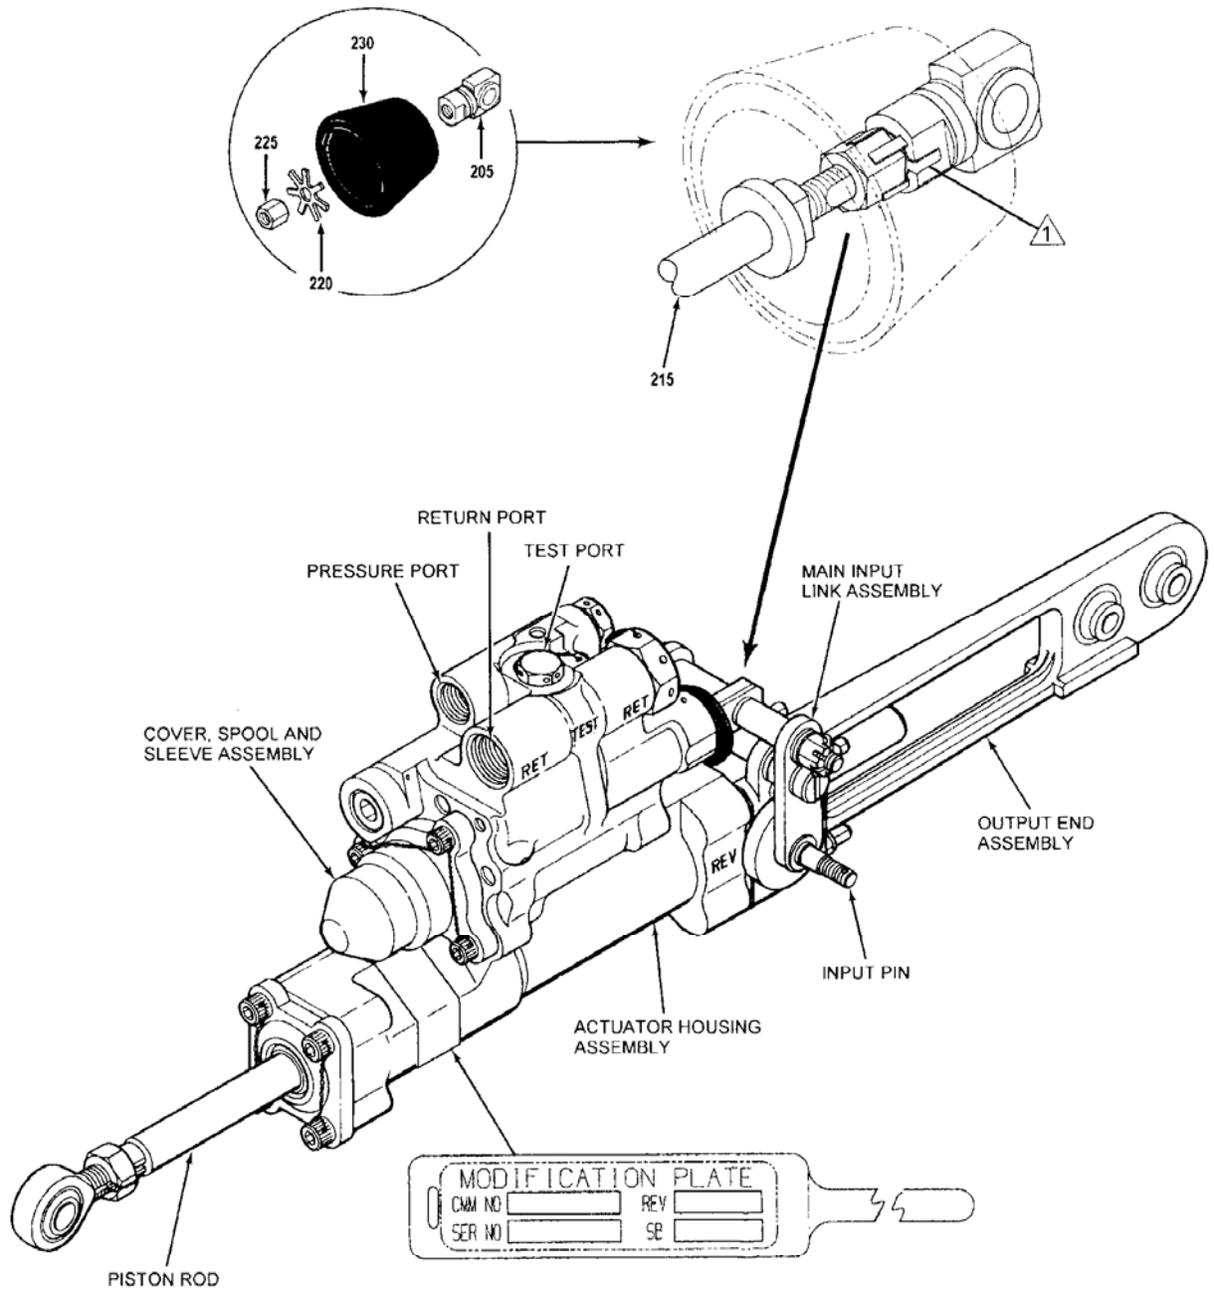
Clevis Assembly
 Figure 1

This Emergency Airworthiness Directive (AD) is prompted by a report that a quality escape by a supplier has occurred and certain hydraulic servo actuators (servo) may have a loose nut, shaft, and clevis assembly due to improper lock-washer installation. An investigation after an accident revealed the clevis nut on the servo was loose. This condition, if not detected, could lead to a malfunction of a servo in the flight control system and subsequent loss of control of the helicopter.

To detect loose or misaligned parts of the servo that could lead to failure of the servo and subsequent loss of control of the helicopter, do the following:

△ ACCEPTABLE CONDITION
 A MINIMUM OF ONE TAB SHALL BE IN LINE AND BENT FLUSH WITH THE NUT FLAT SURFACE AND A MINIMUM OF ONE TAB SHALL BE IN LINE AND BENT FLUSH WITH THE CLEVIS ASSEMBLY FLAT SURFACE

(1) Retract the boot depicted as “230” in Figure 1 of this AD:

(2) Applying only hand pressure, determine whether the nut, shaft, or clevis assembly, depicted as “225,” “215,” and “205,” respectively, in Figure 1 of this AD, turns independently. If the shaft turns independently of the nut or the clevis assembly, before further flight, replace the servo with an airworthy servo.

(3) If the shaft does not turn independently, inspect to determine whether at least one tab of the lock washer is bent flush against a flat surface of the nut and at least one tab of the lock washer is bent flush against a flat surface of the clevis assembly.

(i) If at least one lock washer tab is not aligned and bent flush with a nut flat surface and at least one lock washer tab is not aligned and bent flush with a flat surface of the clevis assembly, before further flight, replace the servo with an airworthy servo.

(ii) If any tab of the lock washer is not bent flush against either a flat surface of the nut or clevis assembly, bend the tab flush against a flat surface.

(4) After accomplishing paragraph (a)(1) through (a)(3) of this AD, reidentify the servo by metal-impression stamping or by vibro etching “67-01” onto the modification plate.
