**FEDERAL AVIATION ADMINISTRATION
AIRWORTHINESS DIRECTIVES**

BIWEEKLY 2012-24

2012-10-53 Eurocopter Deutschland GMBH (ECD): Amendment 39-17254; Docket No. FAA-2012-1188; Directorate Identifier 2012-SW-049-AD.

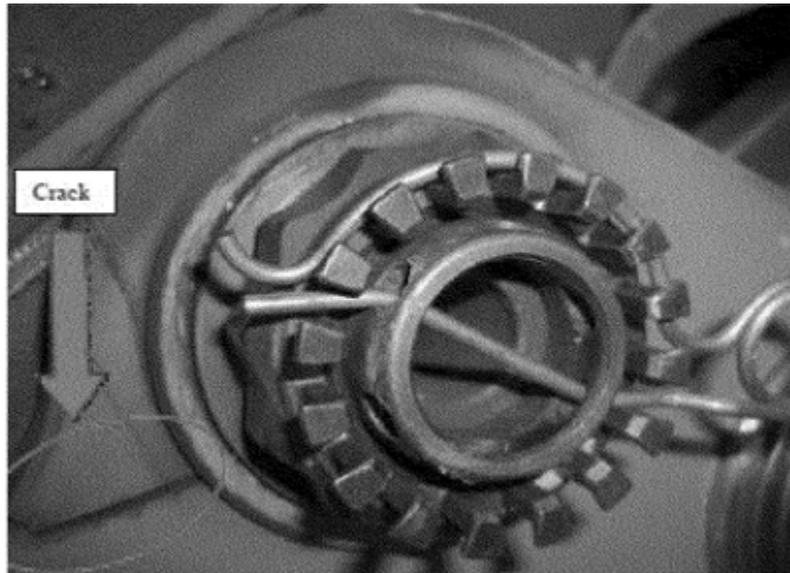
Figure 1 to Paragraph (f)(1)

This AD defines the unsafe condition as a crack in the MRH shaft flange, which could result in failure of the MRH shaft and subsequent loss of control of the helicopter.

(1) Before further flight, and thereafter at intervals not to exceed 6 hours time-in-service (TIS), check the MRH shaft lower flange and the visible area of the MRH shaft upper flange for a crack. Figures 1 and 2 to Paragraph (f)(1) of this AD are examples of cracks that have been discovered in the MRH shaft lower flange. The actions required by this paragraph may be performed by the owner/operator (pilot) holding at least a private pilot certificate, and must be entered into the aircraft records showing compliance with this AD in accordance with 14 CFR 43.9 (a)(1)-(4) and 14 CFR 91.417(a)(2)(v). The record must be maintained as required by 14 CFR 91.417, 121.380, or 135.439.

(3) If there is a crack in the upper or lower MRH shaft flange, before further flight, replace the MRH shaft. Replacing the MRH shaft with an MRH shaft having a part number listed in the applicability of this AD does not constitute terminating action for the requirements of this AD.

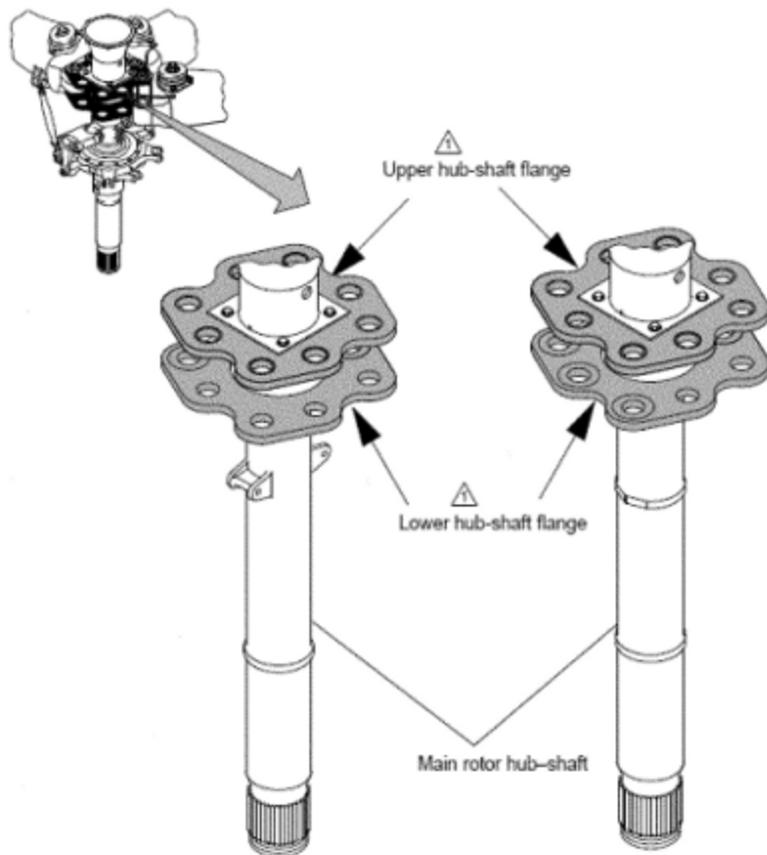
- (2) For MRH shafts with 400 or more hours TIS, within 10 hours TIS, and thereafter at intervals not to exceed 10 hours TIS:
- (i) Remove rotor-hub cap.
 - (ii) Clean the upper and lower MRH shaft flange as depicted in Figure 3 to Paragraph (f)(2)(ii) of this AD and visually inspect for a crack.

⚠ Check visible area of the upper and lower hub-shaft flange.

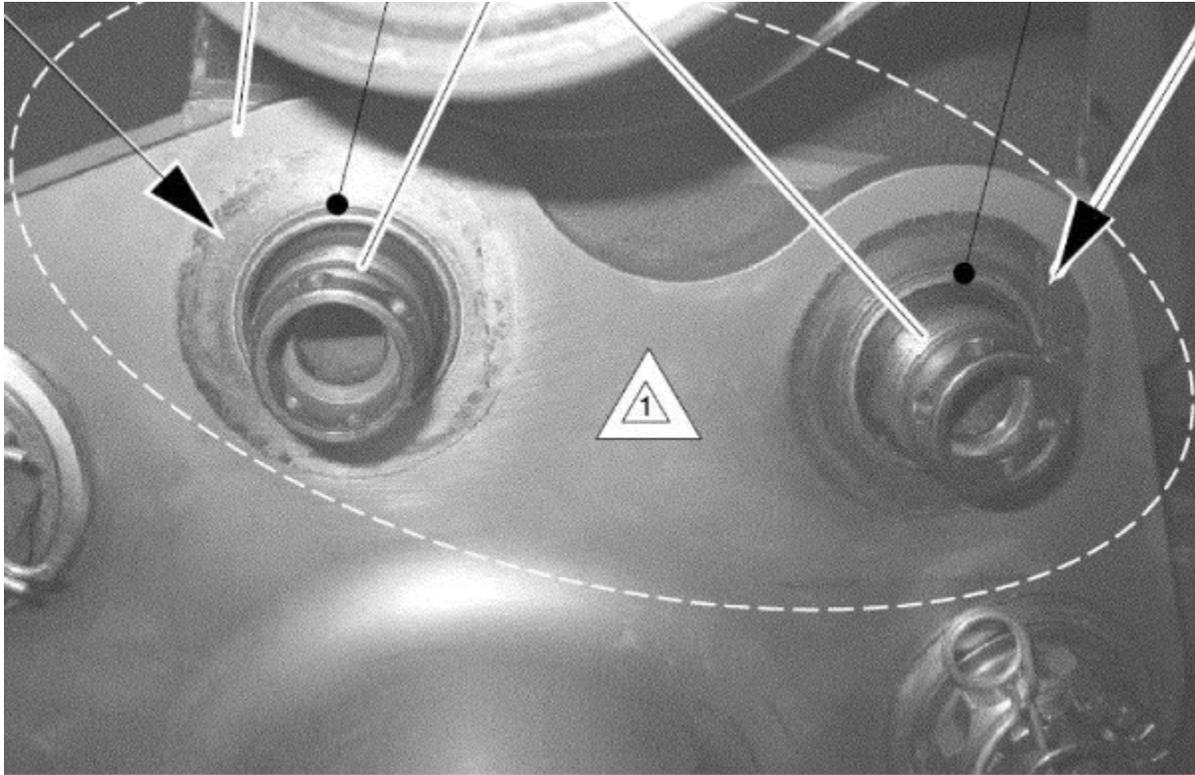
(v) Using a 10X or higher power magnification, inspect all lower MRH shaft flange blade bolt attachment areas for a crack as shown in Figure 4 to Paragraph (f)(2)(v) of this AD.
