**FEDERAL AVIATION ADMINISTRATION
AIRWORTHINESS DIRECTIVES
LARGE AIRCRAFT**

BIWEEKLY 2011-18

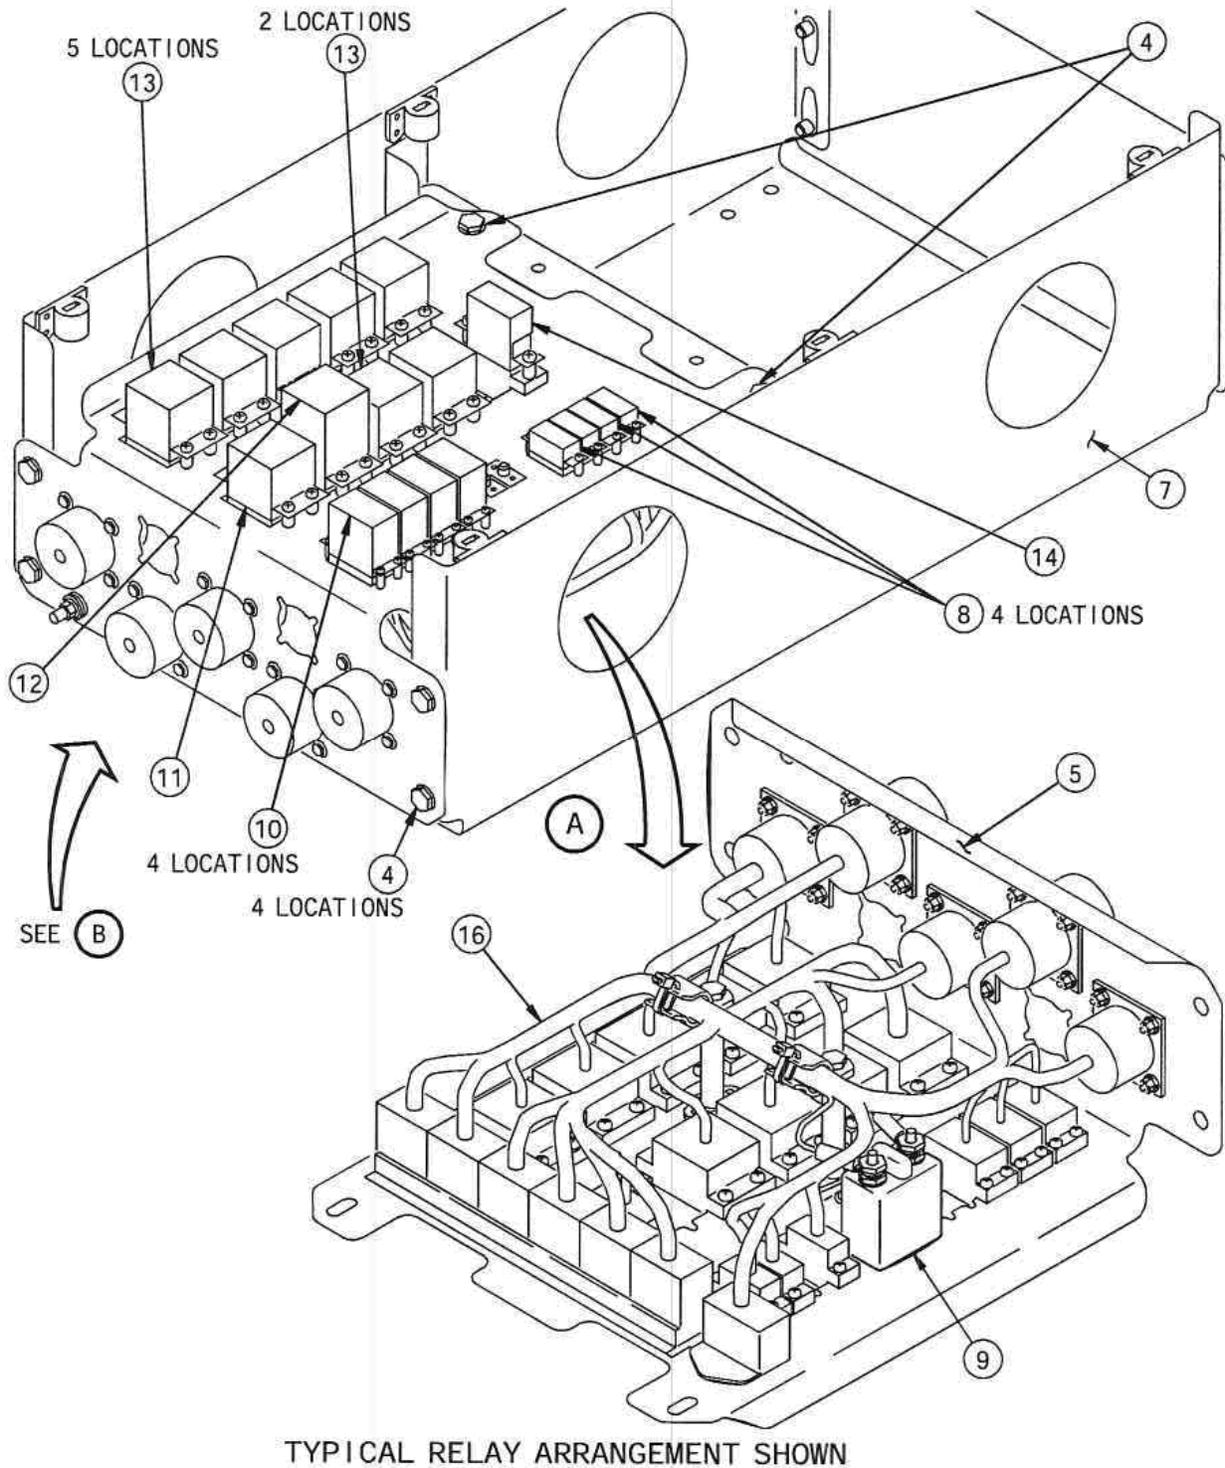
(e) This AD was prompted by fuel system reviews conducted by the manufacturer. We are issuing this AD to prevent center tank fuel pump operation with continuous low pressure, which could lead to friction sparks or overheating in the fuel pump inlet that could create a potential ignition source inside the center fuel tank. These conditions, in combination with flammable fuel vapors, could result in a center fuel tank explosion and consequent loss of the airplane.

Placard Installation for Mixed Fleet Operation

(g) For airplanes identified in paragraph 1.A.1. of Boeing Alert Service Bulletin 737-28A1206, Revision 2, dated May 21, 2009: Within 36 months after the effective date of this AD, install an automatic shutoff system for the center tank fuel boost pumps, by accomplishing all of the actions specified in Part 1 and Part 2 of the Accomplishment Instructions of Boeing Alert Service Bulletin 737-28A1206, Revision 2, dated May 21, 2009, except that Figure 1 of this AD must be used in lieu of Sheet 2 of Figure 11 of Boeing Alert Service Bulletin 737-28A1206, Revision 2, dated May 21, 2009. If a placard has been previously installed on the airplane in accordance with paragraph (h) of this AD, the placard may be removed from the flight deck of only that airplane after the automatic shutoff system has been installed. Installing automatic shutoff systems on all airplanes in an operator's fleet, in accordance with this paragraph, terminates the placard installation required by paragraph (h) of this AD for all airplanes in an operator's fleet.
